CASE STUDY

A lesson well learned

Project: Layfield Primary School

Membrane: SIGNature Bituminous Membrane

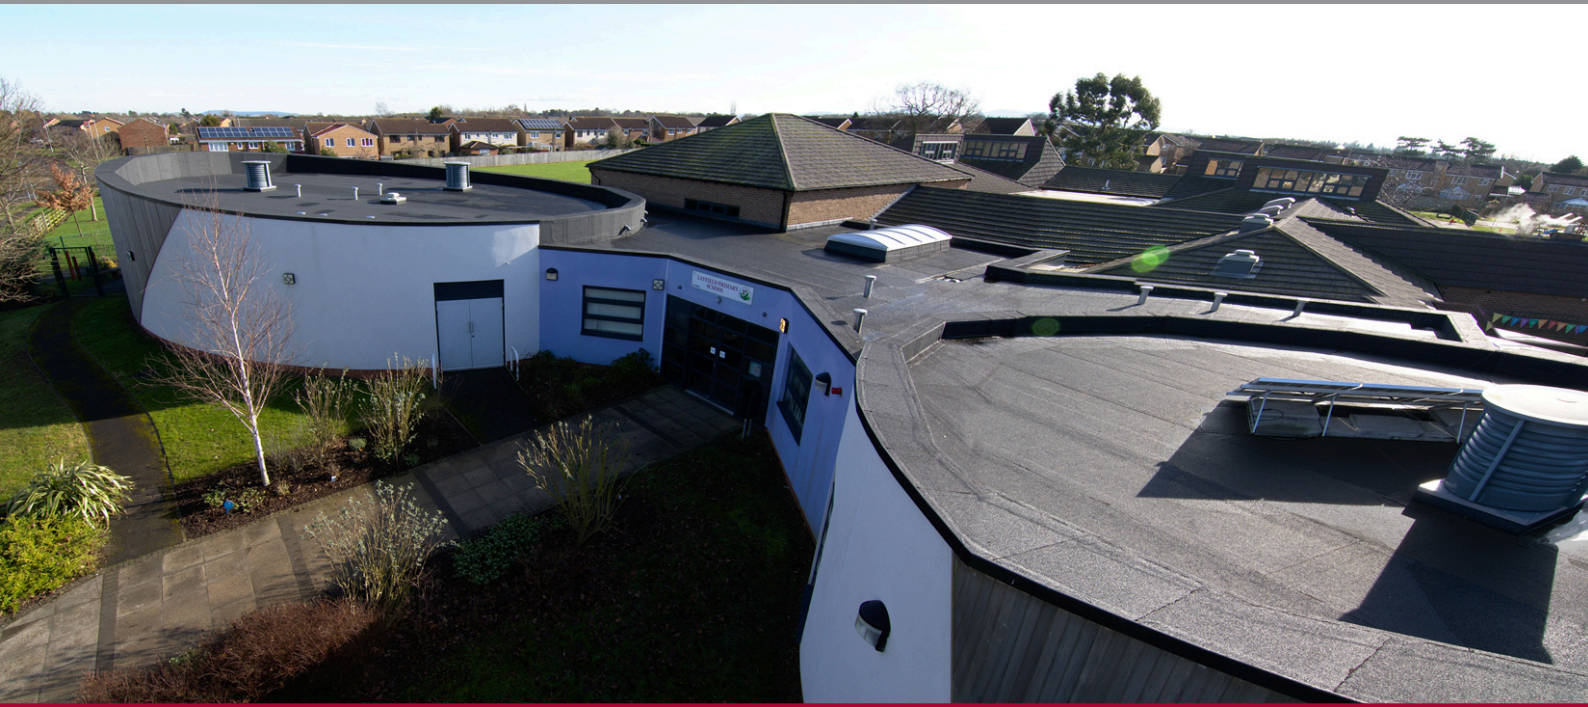
The new overlaid roof at Layfield Primary

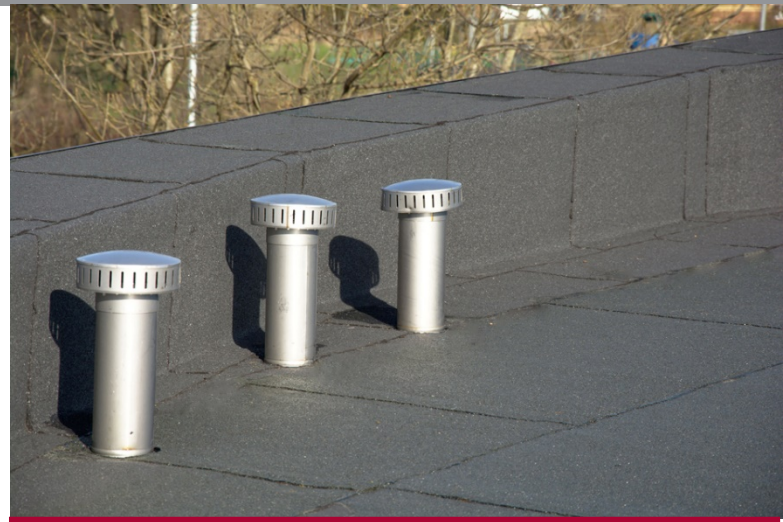
The leaking roof area consisted of two pitched oval roofs with a flat roof below. SIG's investigation identified the cause of the problem as the oval roofs, where inadequate detailing around the perimeter upstands and at the intersection with the lower roof had allowed water to ingress and find its way through to beneath the flat roof and down the walls into the school.

A crucial phase of the work was the correct detailing of the junctions with the flat roof.

The second, crucial phase of the work was the correct detailing of the junctions with the flat roof and the upstands around the roof perimeter. Roofix Ltd found a way to close mitre cut and bend the GRP trim insitu to fully encapsulate the upstand as an alternative to the original failed metal capping.

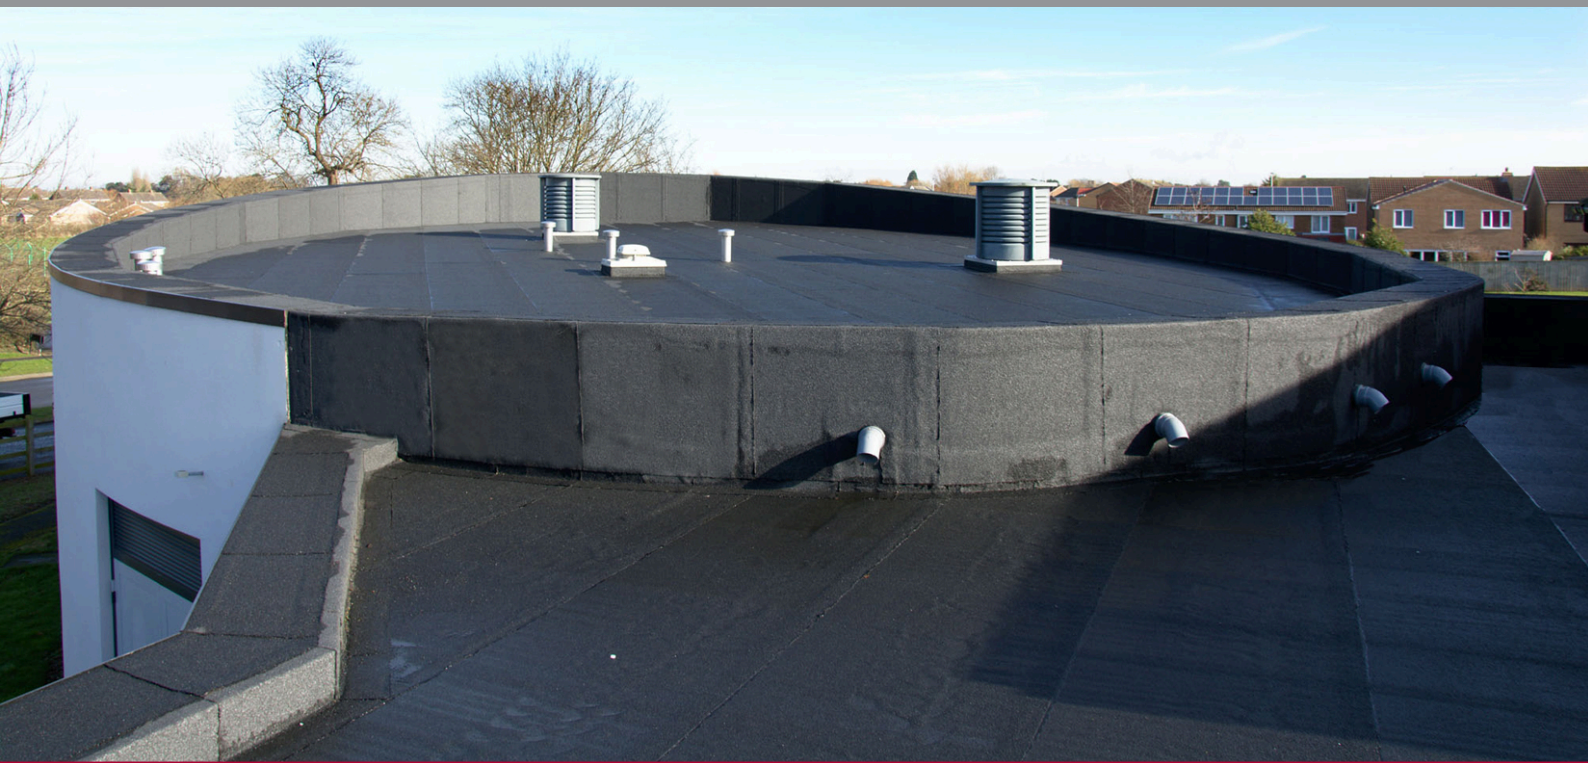
By avoiding complete stripping of the failed roofs, this strategy provided significant cost savings.
