Heritage market building gets the Hydrostop AH+ treatment to restore civil pride

Project: Plymouth Market, Devon

Liquid waterproofing system: Hydrostop AH+

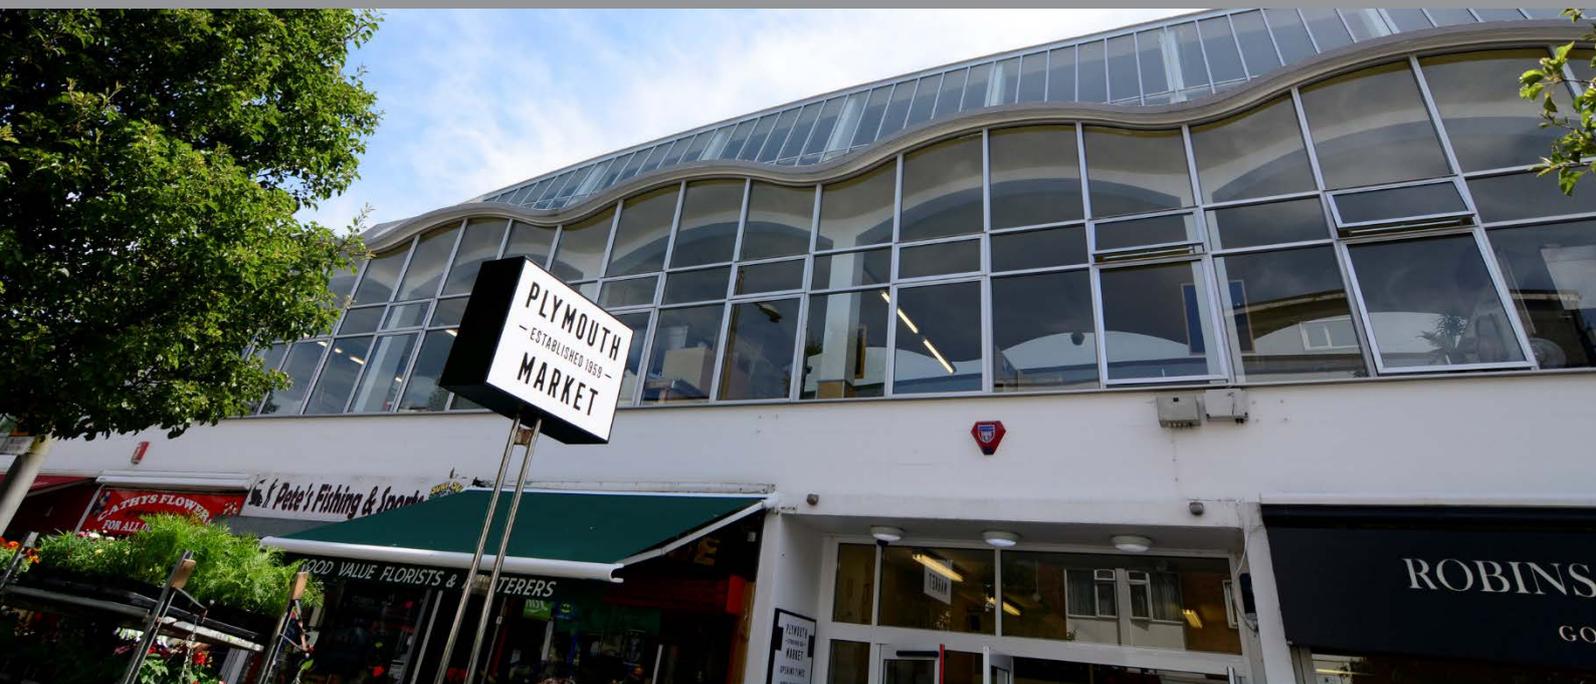
Plymouth Market, designed by local architects, Walls and Pearn was built in the west end of Plymouth to support trade in that area and replaced the original city market, which was destroyed in the Blitz of 1941.

In addition to its history, the building is noteworthy because of its height and distinctive vaulted roof design. The main roofing area is comprised of a curved shell formation, which added to the challenges of re-roofing.

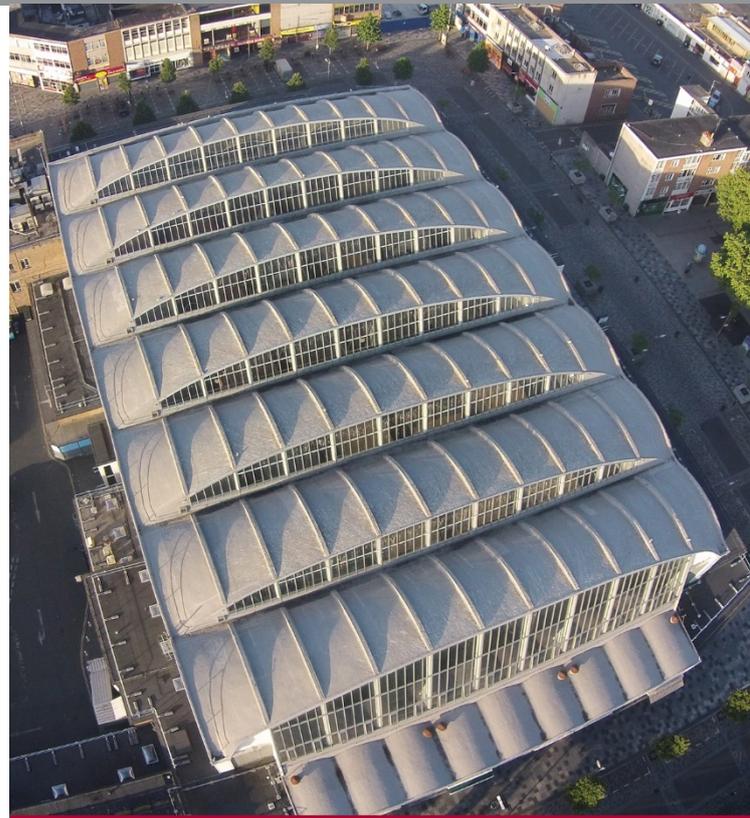
Hydrostop AH+ provided the perfect solutions, allowing traders to continue "business as usual" while roofing work was in progress

Hydrostop AH+ is a one component product which offers significant advantages over conventional PU and PMMA systems and has a warranty for up to 25 years. Very low in odour and fast-curing, it is fully reinforced with a polyester fabric. It can be applied under practically any conditions - even as low as 0°C such as during the winter months when the Plymouth Market refurbishment was underway.

The roofing team had to deal with difficult access due to the elevation of the building and steep slopes of the roofing shell waves – which were in complete contrast to typical flat roofing projects where they had previously applied the product.

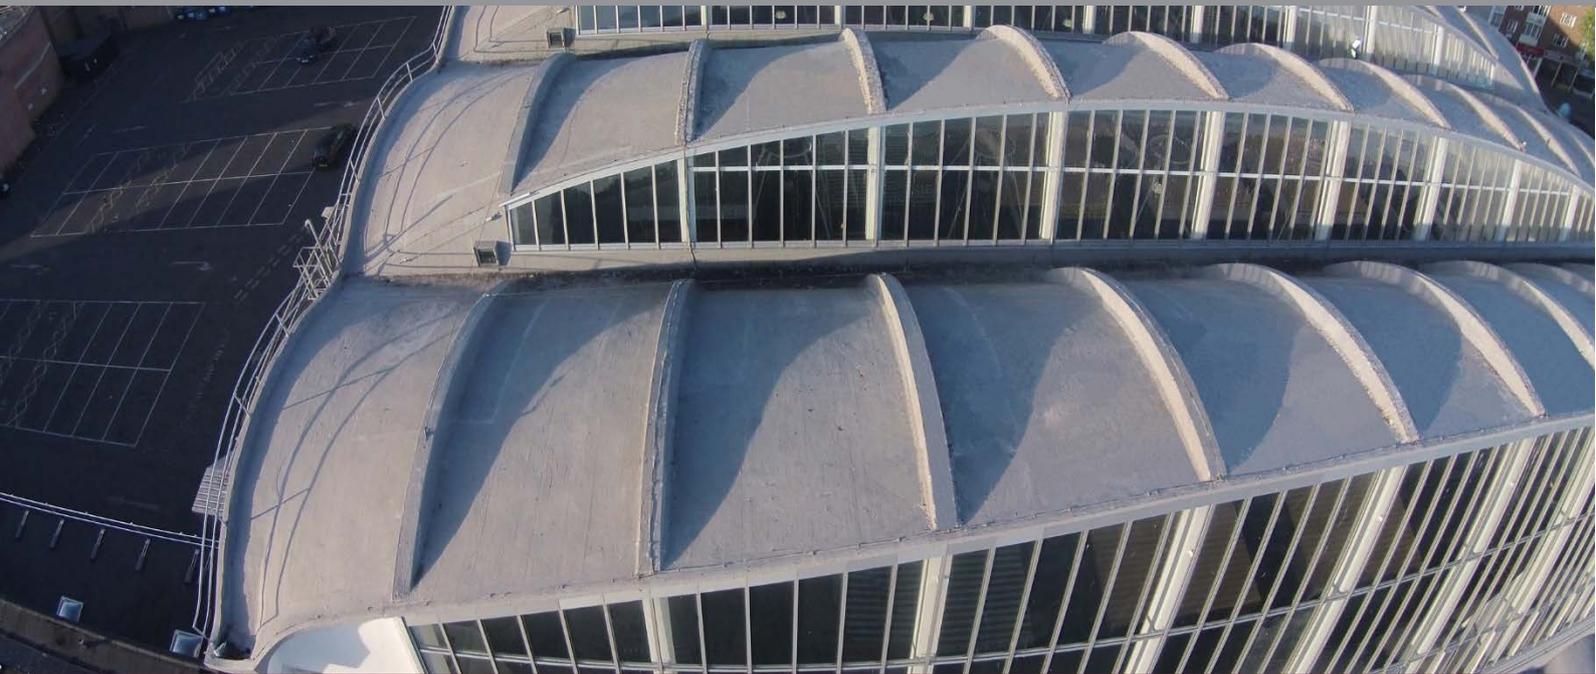
However, with its paint-on system, Hydrostop AH+ proved to be “a very good product” for the repair of the wave form main roof, as well as being used in tackling repairs to two smaller canopy roofs at the market.

Due to the building’s listed status, Historic England supervised and approved the refurbishment. SIG asked the Hydrostop AH+ manufacturers to create a colour – Weathered Silver – specifically for the market roof membrane repair, in keeping with Historic England’s requirements.
