CPD Seminar Handout:

Roof Refurbishment: Choosing the Best Solution

CPD handout: November 2017

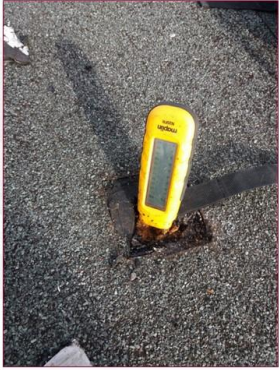
Stage 1: Diagnostic testing

- Core sample
- Moisture mapping
- Thermographic imaging

Core sampling a roof involves physically removing a portion of the membrane and insulation layers to ascertain condition of roofing system components.

Moisture mapping uses meters to provide photographs or drawings of moisture areas beneath the roof.

Thermographic imaging uses an infrared camera to locate cold spots on a roof caused by wet insulation.

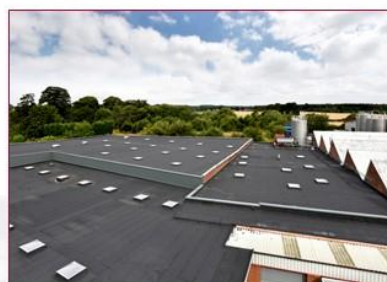
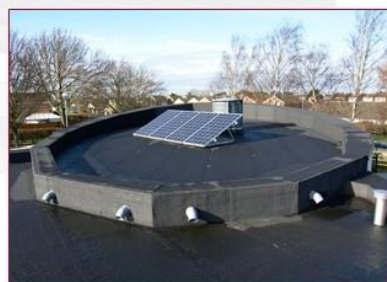
Stage 3: Why specify bitumen

- Over 100 years of experience and development
- Robust product
- Access to roof
- Non-slip hazard
- High durable, long-lasting performance
- Environmentally friendly
- High resistance to mechanical damage and puncturing

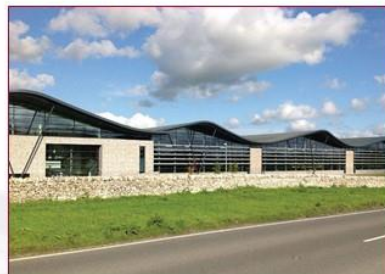
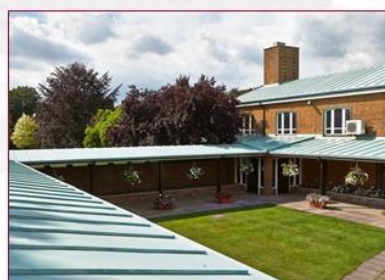
Stage 3: Why specify single ply?

- Over 50 years track record
- Low capital cost and cost in use
- Safe, rapid, clean installation
- High durable, long-lasting performance
- Design flexibility – wave form, cupolas, colours etc
- Easy repair, modification and refurbishment
- Ideal surface for subsequent photovoltaic systems
- Environmentally friendly & good reflectivity

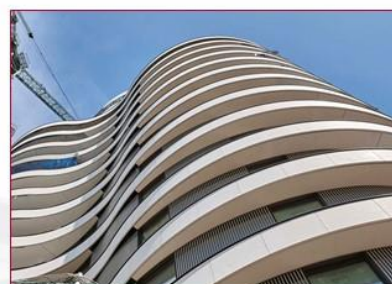
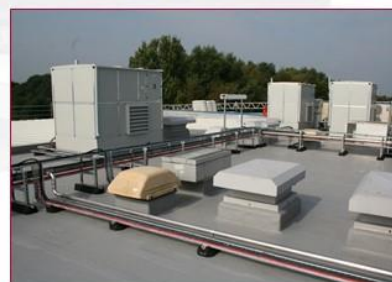
Stage 3: Why specify liquid coating?

- A wet-on-wet, cold applied liquid waterproofing product
- Fully reinforced with a polyester fabric
- Free of solvents and isocyanates
- Very low in VOCs, fume free, virtually odourless
- Seamless waterproofing system, ideal for complex detailing
- Can apply in cold temperatures above 0°C
- Water repellent on application

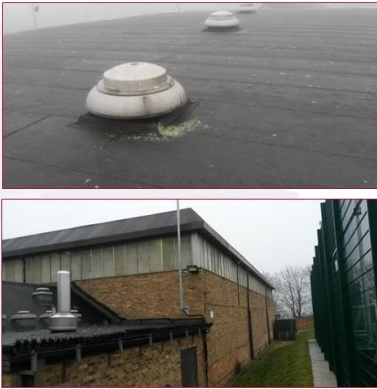
Roof survey

- Fragile deck
- Saturated build-up
- Aged roof on metal deck
- Mansard details slipping
- Incorrect pitched roof areas
- Height issues
- Defective glazing units
- GRP sheets failed
- Concrete tiles starting to fail

The roof survey identified a number of problems

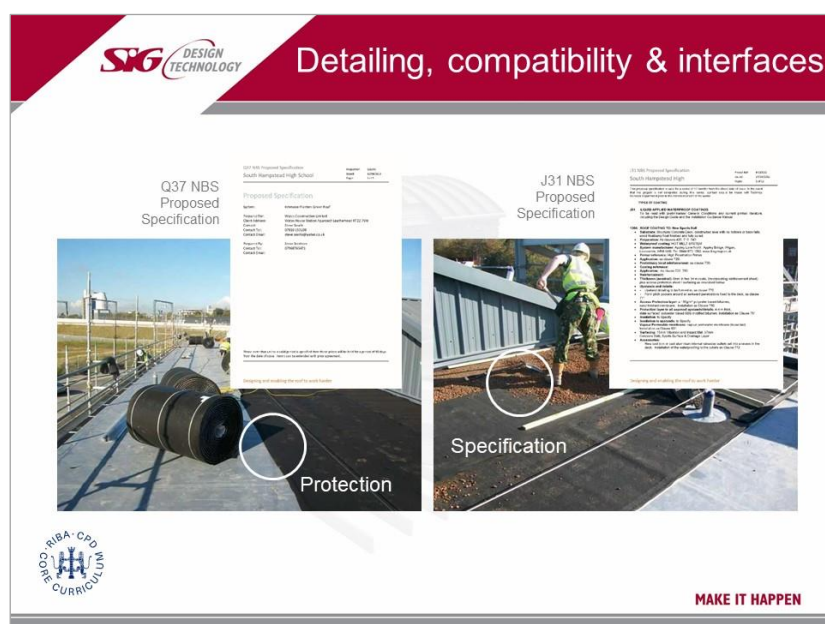
These two images show where the integrity of the membrane can compromise the NBS specification by puncturing the membrane, ultimately leading to water ingress

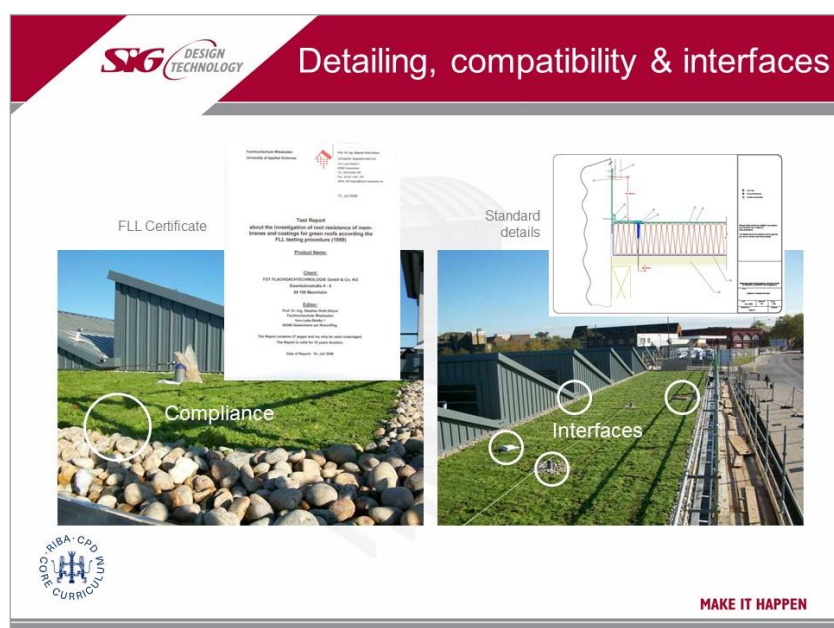
However, by using the correct materials (in the case of this membrane with a FLL certificate) and standard detailing to avoid puncturing the membrane, these roof membrane systems are not punctured at interfaces and do not risk water ingress.
