CASE STUDY

Replacement zinc standing seam roof with solar PVs

Project: Princess Elizabeth Hospital, Guernsey – Lighthouse Wards

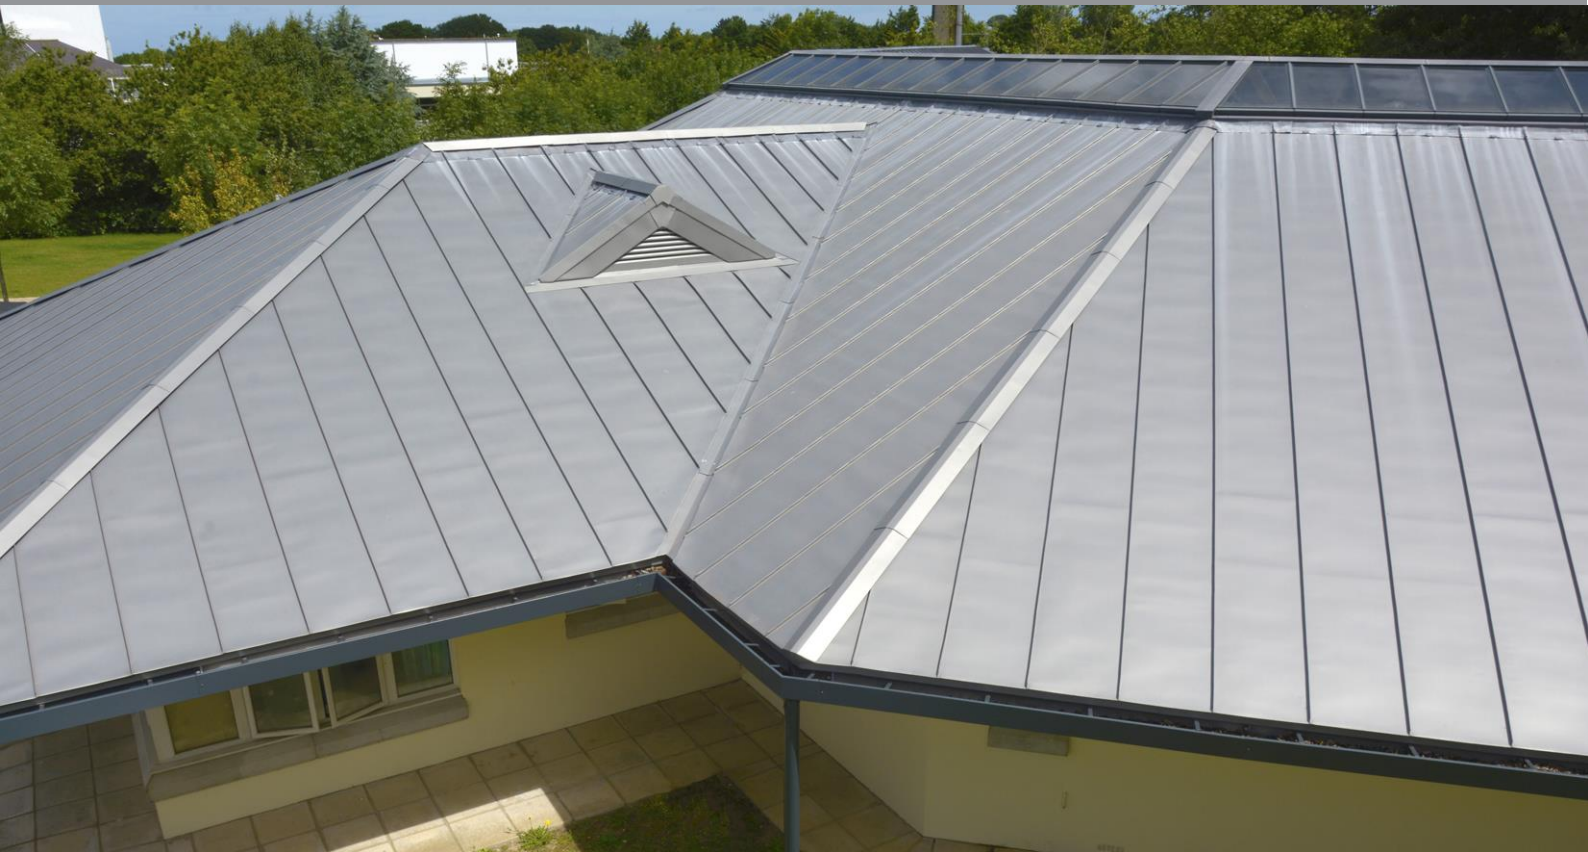
The Lighthouse Wards at Princess Elizabeth Hospital, Guernsey comprise three single storey wards containing 60 continuing care units for elderly patients.

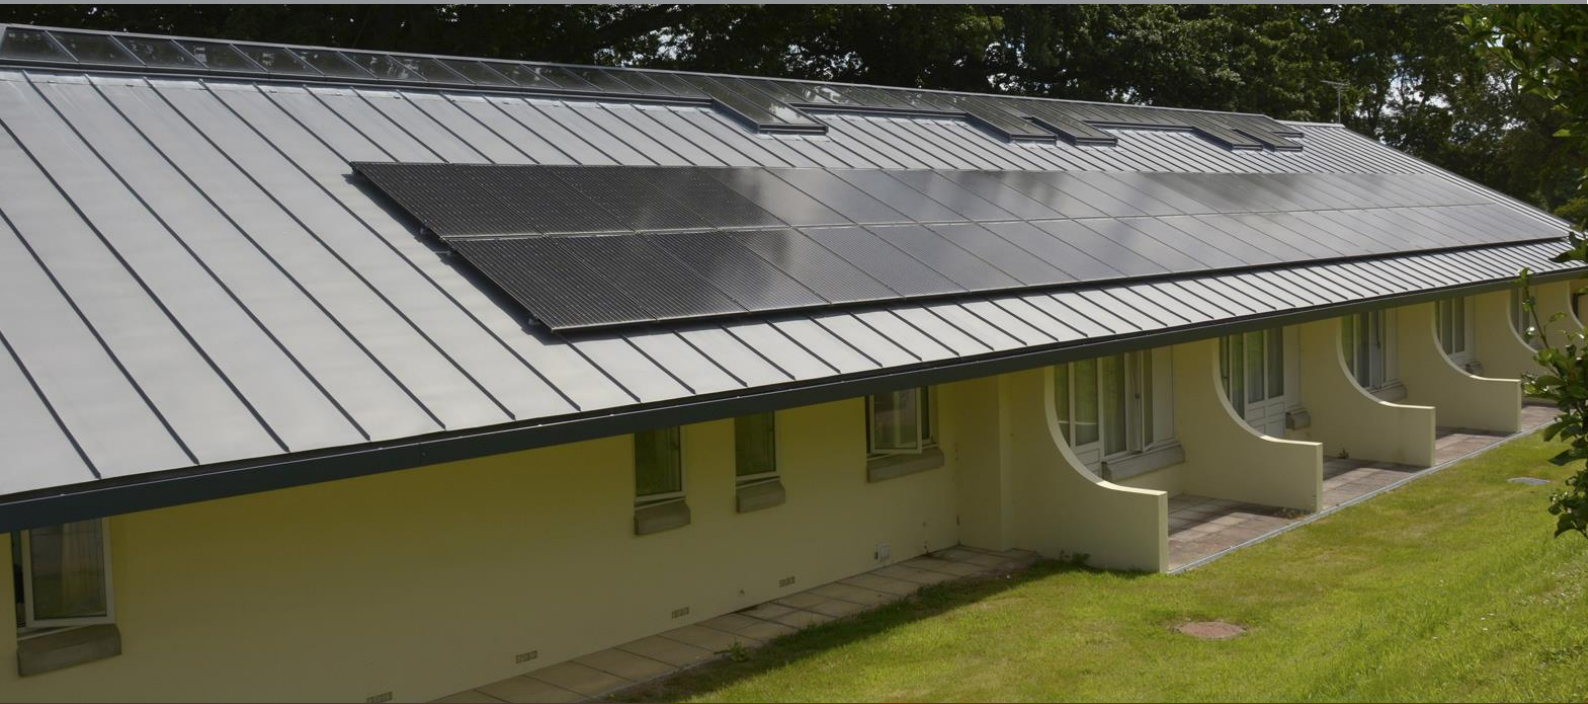
warmer and heating costs have understandably reduced. Whilst nurses were initially concerned about rain noise, we could confirm that this is not a problem with this type of construction, and there have been no issues since the roofs were installed in 2016.
