# R G Scott's architectural jewel restored to former glory with Repoma liquid

**Project:** Our Lady Help of Christians Church, Kitts Green, Birmingham  
**Client:** The Archdiocese of Birmingham  
**Architects:** [APEC Architects](#)  
**Main contractors:** [Midland Conservation Limited](#)  
**Roofing contractors:** [The Rio Group](#)  
**Liquid waterproofing system:** Repoma Rapid Cure in patina green

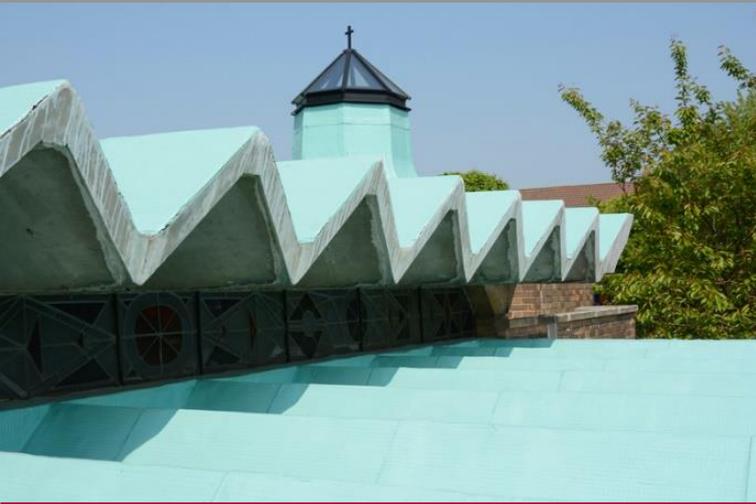
The existing bitumen covering had bonded with the concrete making it impossible to remove without damaging. Repoma can waterproof almost any roof surface without removal.

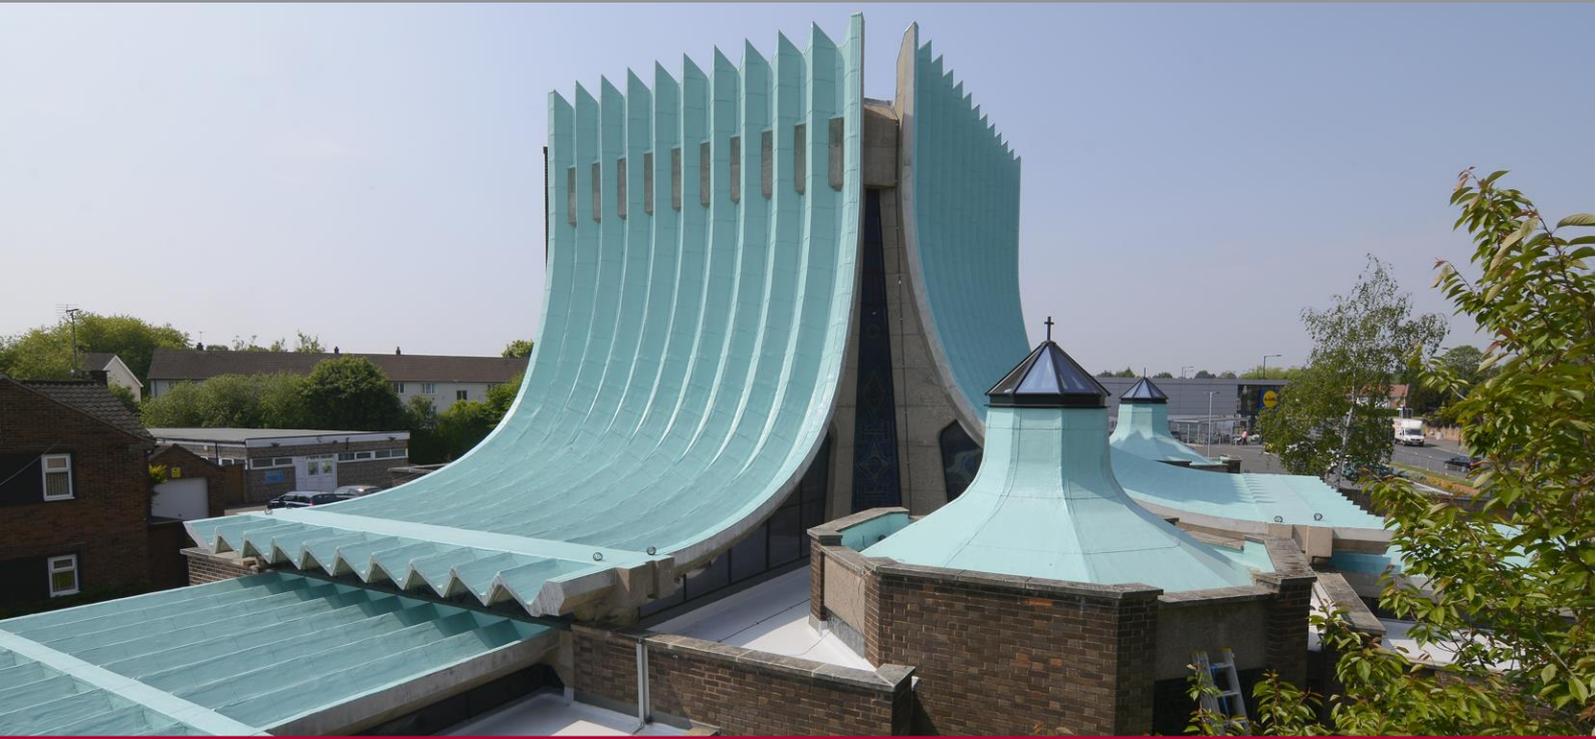
Along with its distinctive obelisk roof, which has an existing copper membrane finish, other features of the Our Lady Help of Christians Church include its striking concrete building envelope

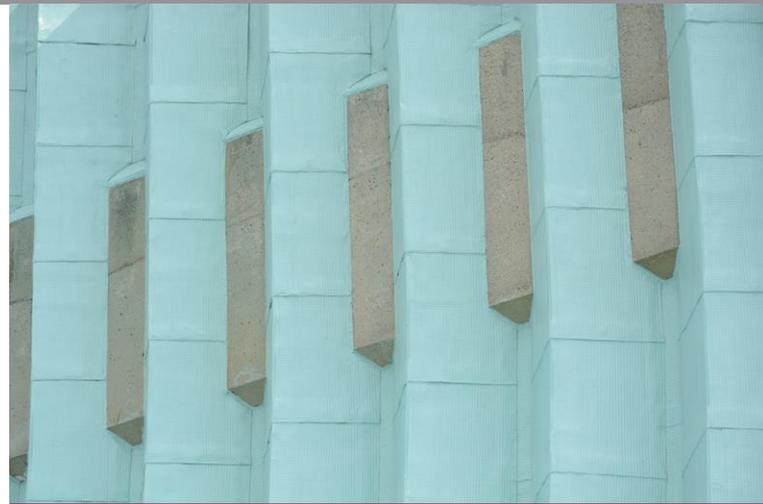
Repoma could be overlaid on the existing membrane, meaning that the pattern and texture of the original finish can still be appreciated

“As a liquid product, it could be overlaid on the existing membrane, meaning that the pattern and texture of the original finish can still be appreciated, something that was critical to retaining the integrity of the original architect's vision.”
